Fifth Judicial District Department of Correctional Services

Facility and Site Study | Final Report December 12, 2008

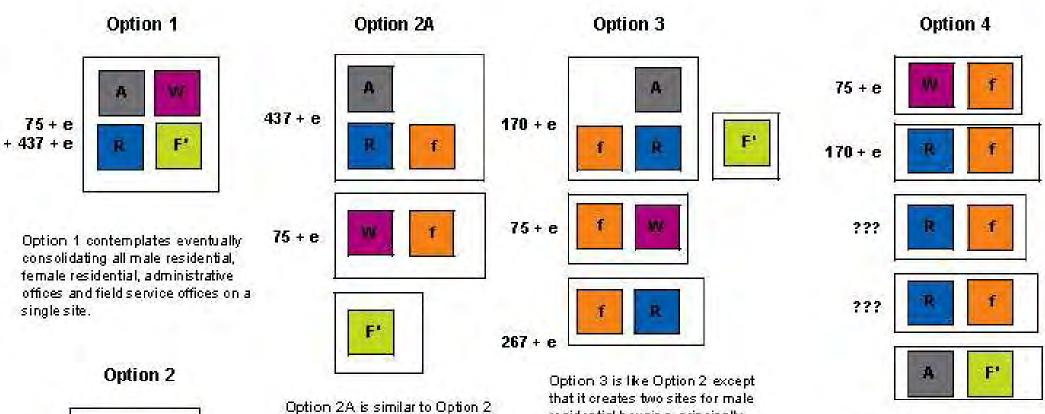
The diagram below conceptually illustrates the building/site master plan concepts examined by the planning team. These concepts describe the larger context into which the 170 new beds might eventually fit. Their importance is in formulating not only initial site requirements for the 170 but long-term site requirements. One notion expressed by all of the concepts is that any residential facility development will be accompanied by appropriate field service offices. The intent is to make field services more efficient and seamless with residential services.

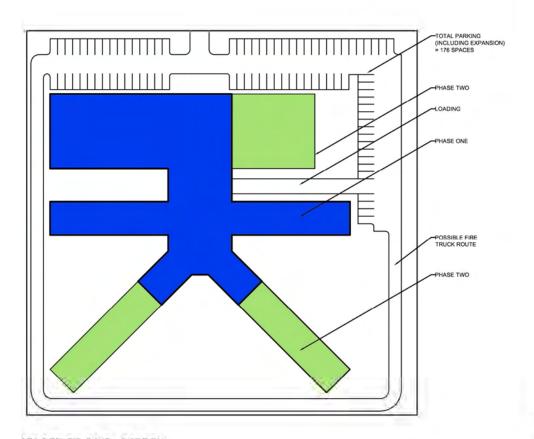
170 BED ROOMS - 2 STORY 5.00 ACRES 50% EXPANSION

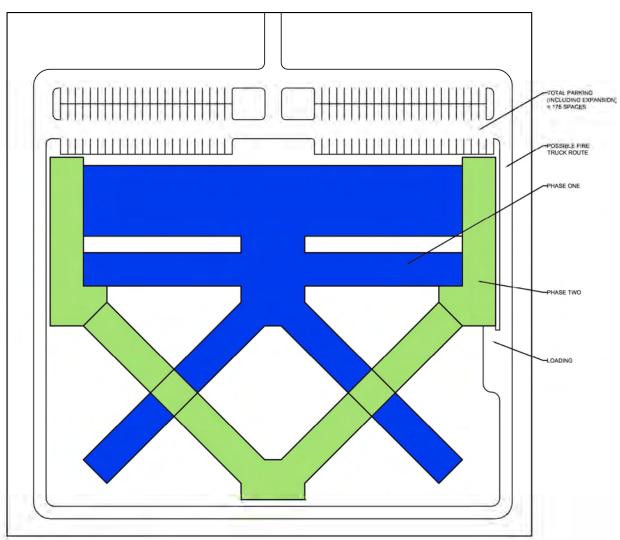
170 BED ROOMS - 1 STORY 7,15 ACRES 50% EXPANSION

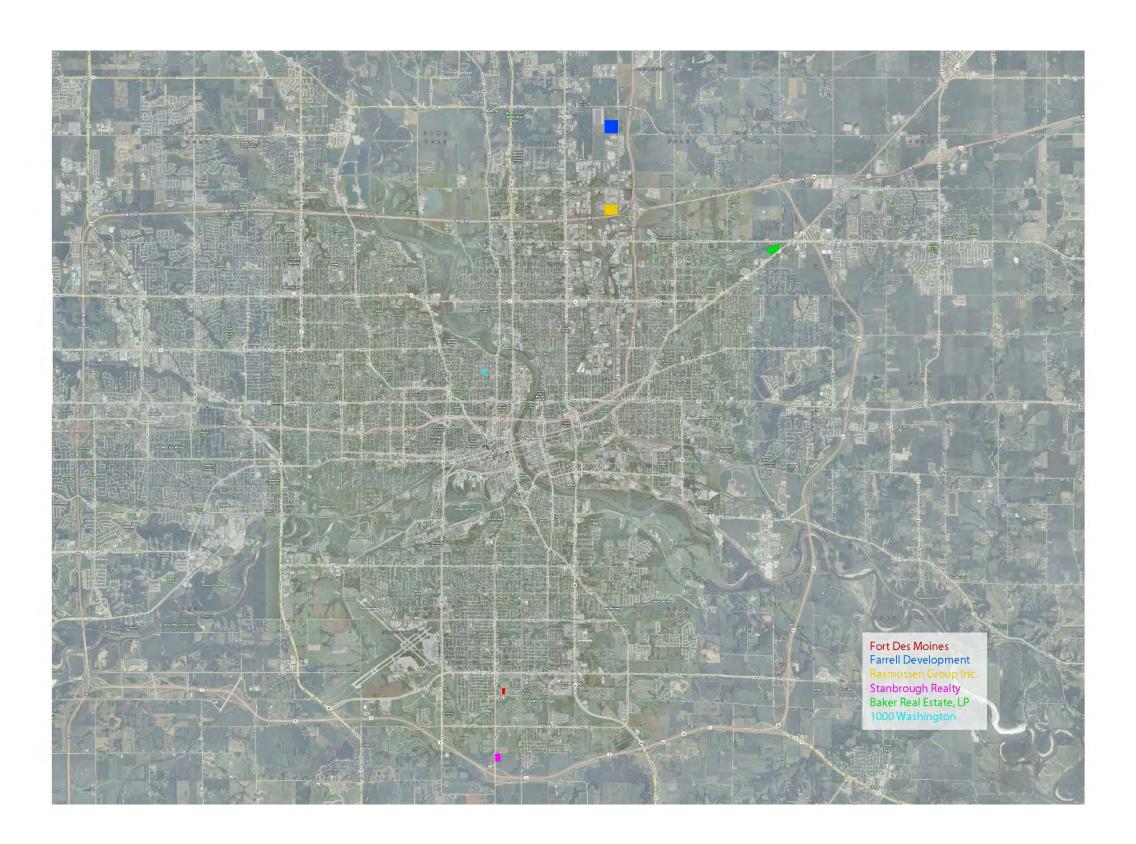
Farrell Development

38.522 acres \$3,081,760.00 \$80,000,00 / acre (some flood plain concerns)
